A promising material for improving therapeutic outcomes in patients

Hyaluronic acid in oral implantology

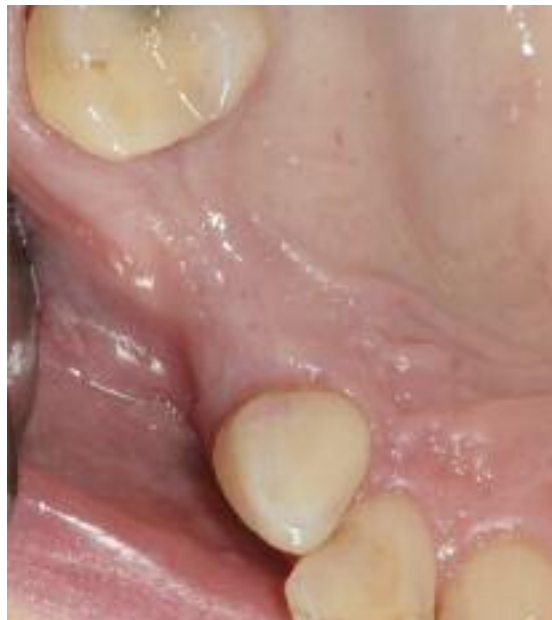
*Fig. 1
Clinical baseline
situation with
missing teeth
14 and 15.*

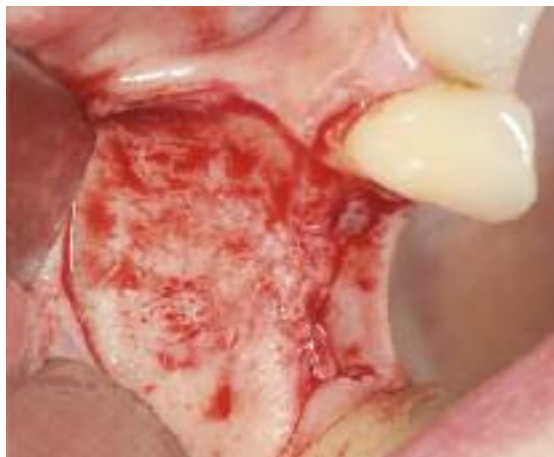
Fig. 2 Preparation of the mucoperiosteal flap to expose the vestibular wall of the maxillary sinus.

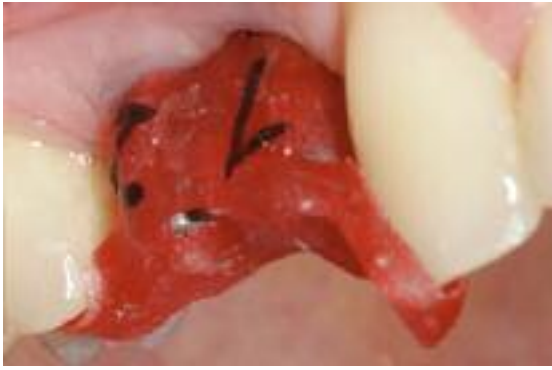
Fig. 19 Pattern resin index to test the correct placement of the abutments.

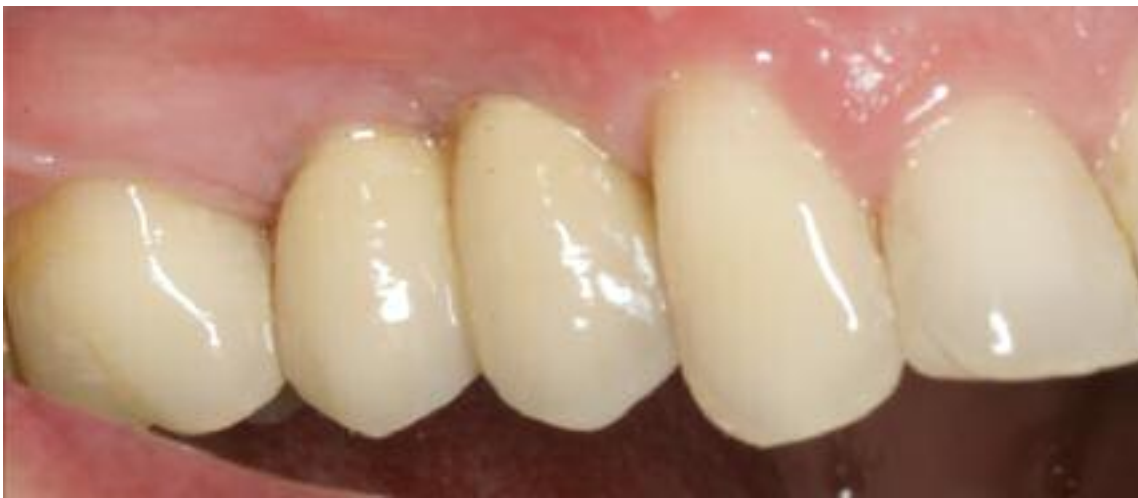
Fig. 21 Prosthetic placement of Bone Trust Plus implants at sites 14 and 15.
